Houston Ball Field Erosion Study

A 3RQ GAPS Project with the Upper Chartiers Creek Watershed Association

Sarah Nelson
Civil Engineering Major and WVWRI Student Worker

1/16/2025
WVWRI Seminar Series

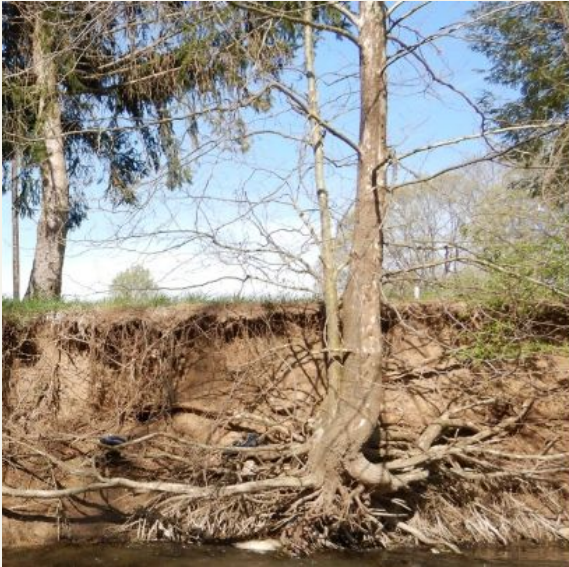
A

Pins were installed within 3 subsections representing the bank conditions within the study area.

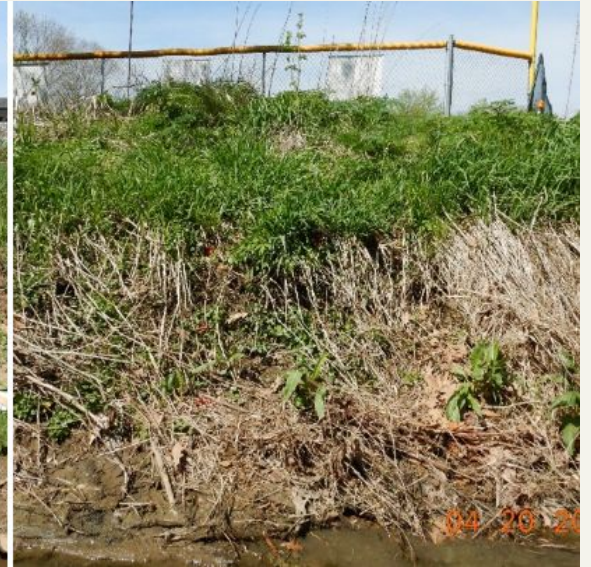
- Erosion was measured (visually and numerically) at all three subsections
- 5 of 6 pins located in subsection C were washed out in winter/early spring, indicating that it should be prioritized for streambank stabilization

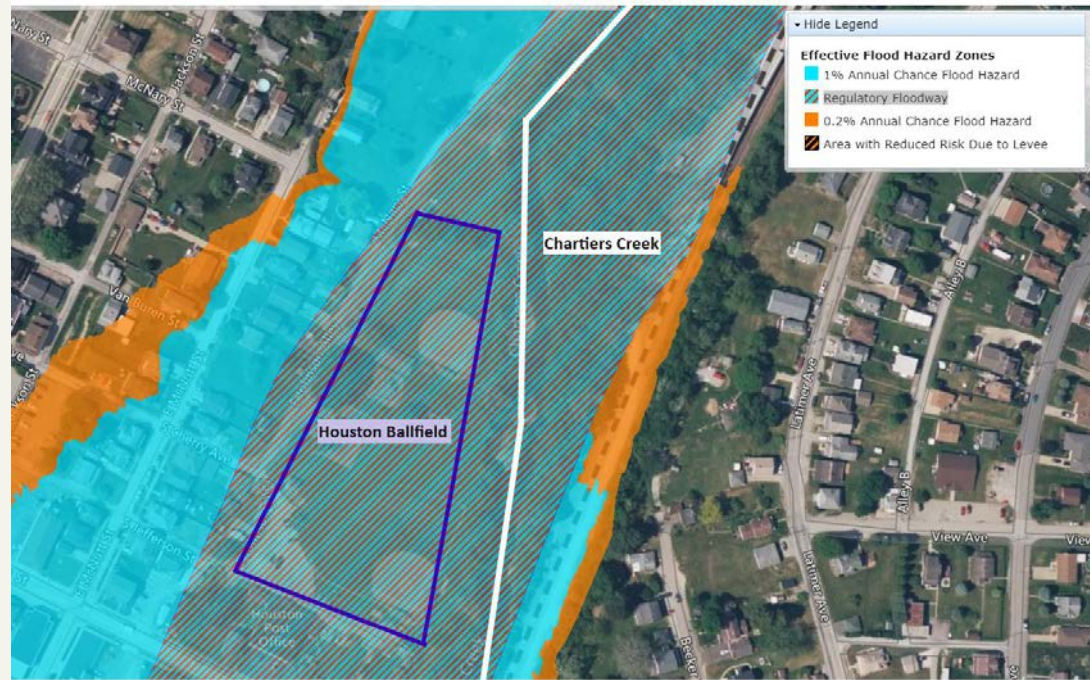
- Significant flooding occurred at the site in early April
- Imaging from the PA Flood Risk Map shows that Houston Ball Field is a regulatory floodway
 - Regulatory floodway - the channel of a river or other watercourse and the adjacent land area that is reserved from encroachment in order to discharge the base flood without cumulatively increasing the water-surface elevation by more than a designated height
- These floodways ensure that there are no increases in upstream flood elevations
- It is **crucial** that proactive steps be taken to stabilize the stream bank since research points to an increase in severity and frequency of flooding due to climate change
