upstream
pittsburgh

Nine Mile Run Watershed

Commercial St. Culvert Monitoring Planning

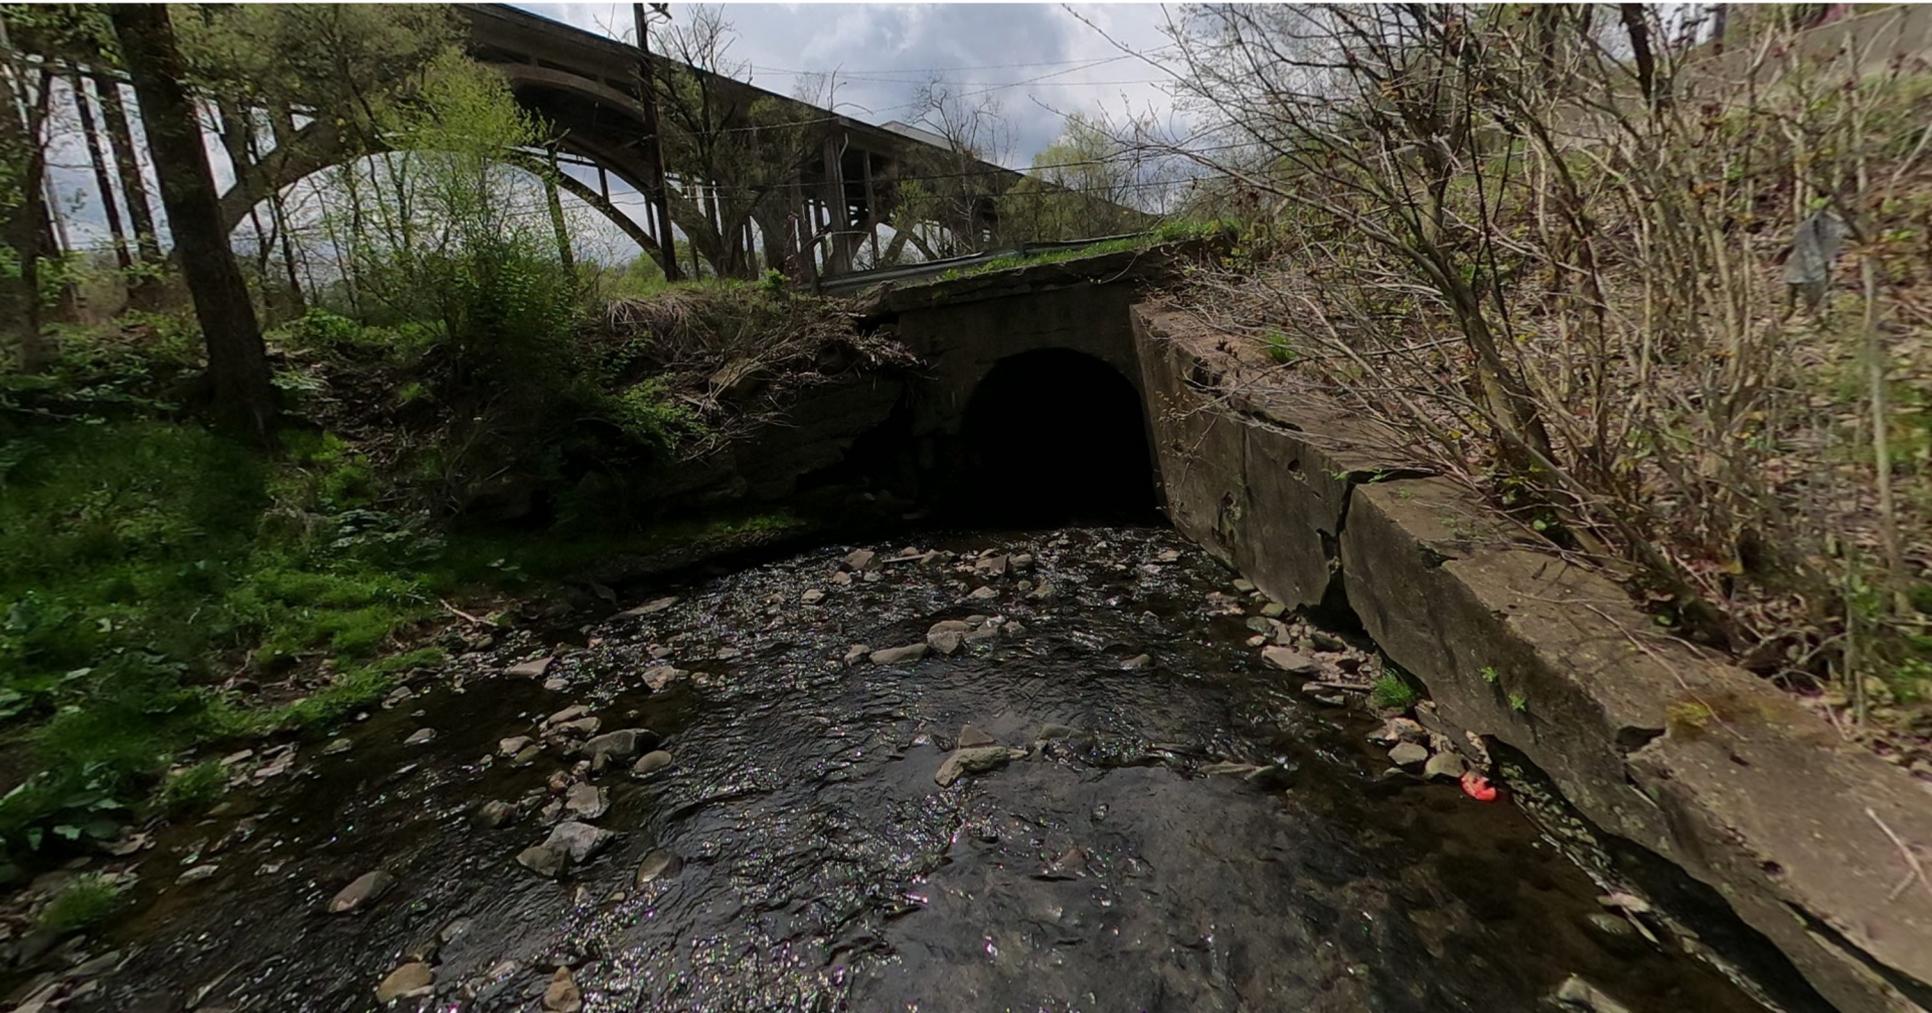
Commercial St. Culvert

Upstream End of Commercial St Culvert

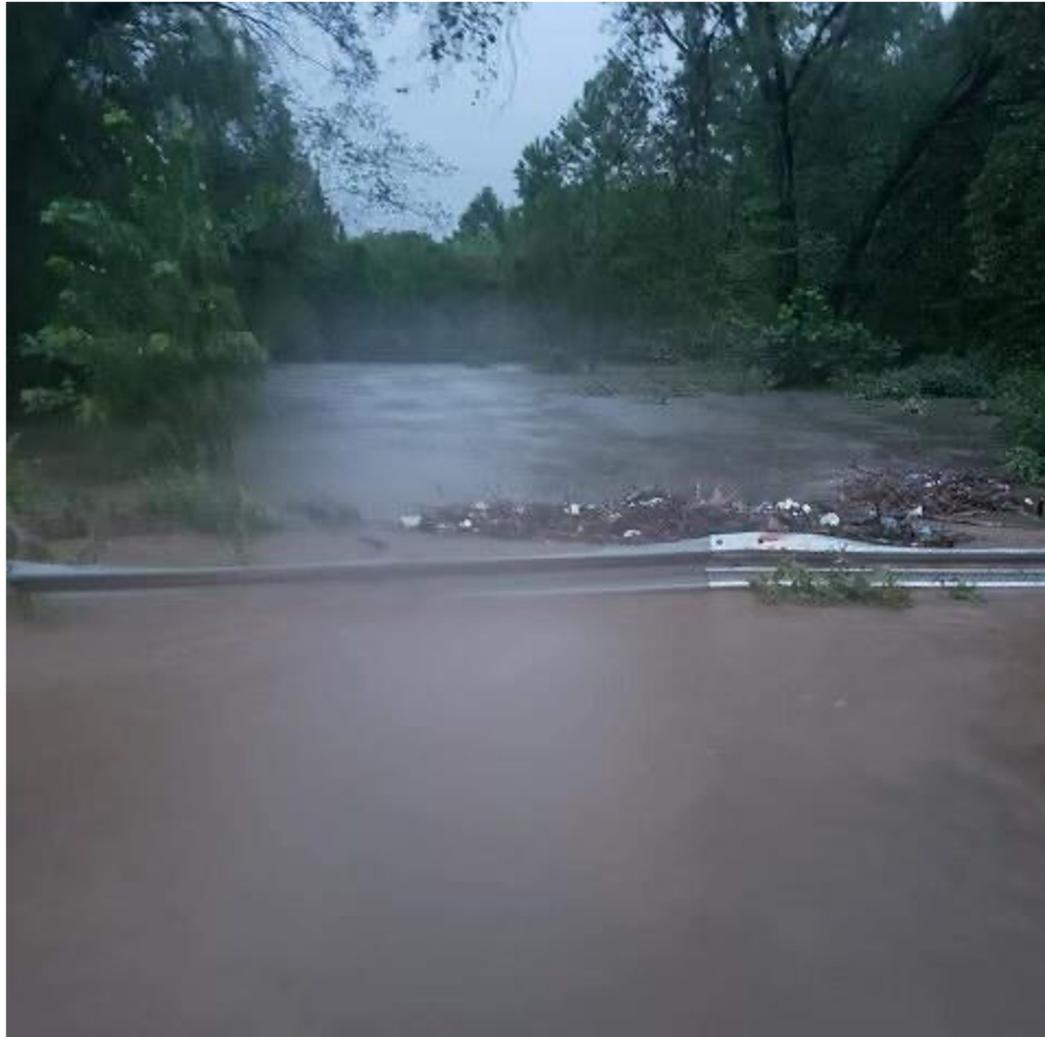
Commercial St. Culvert

View from Commercial street looking upstream during flooding, September 15th, 2021.

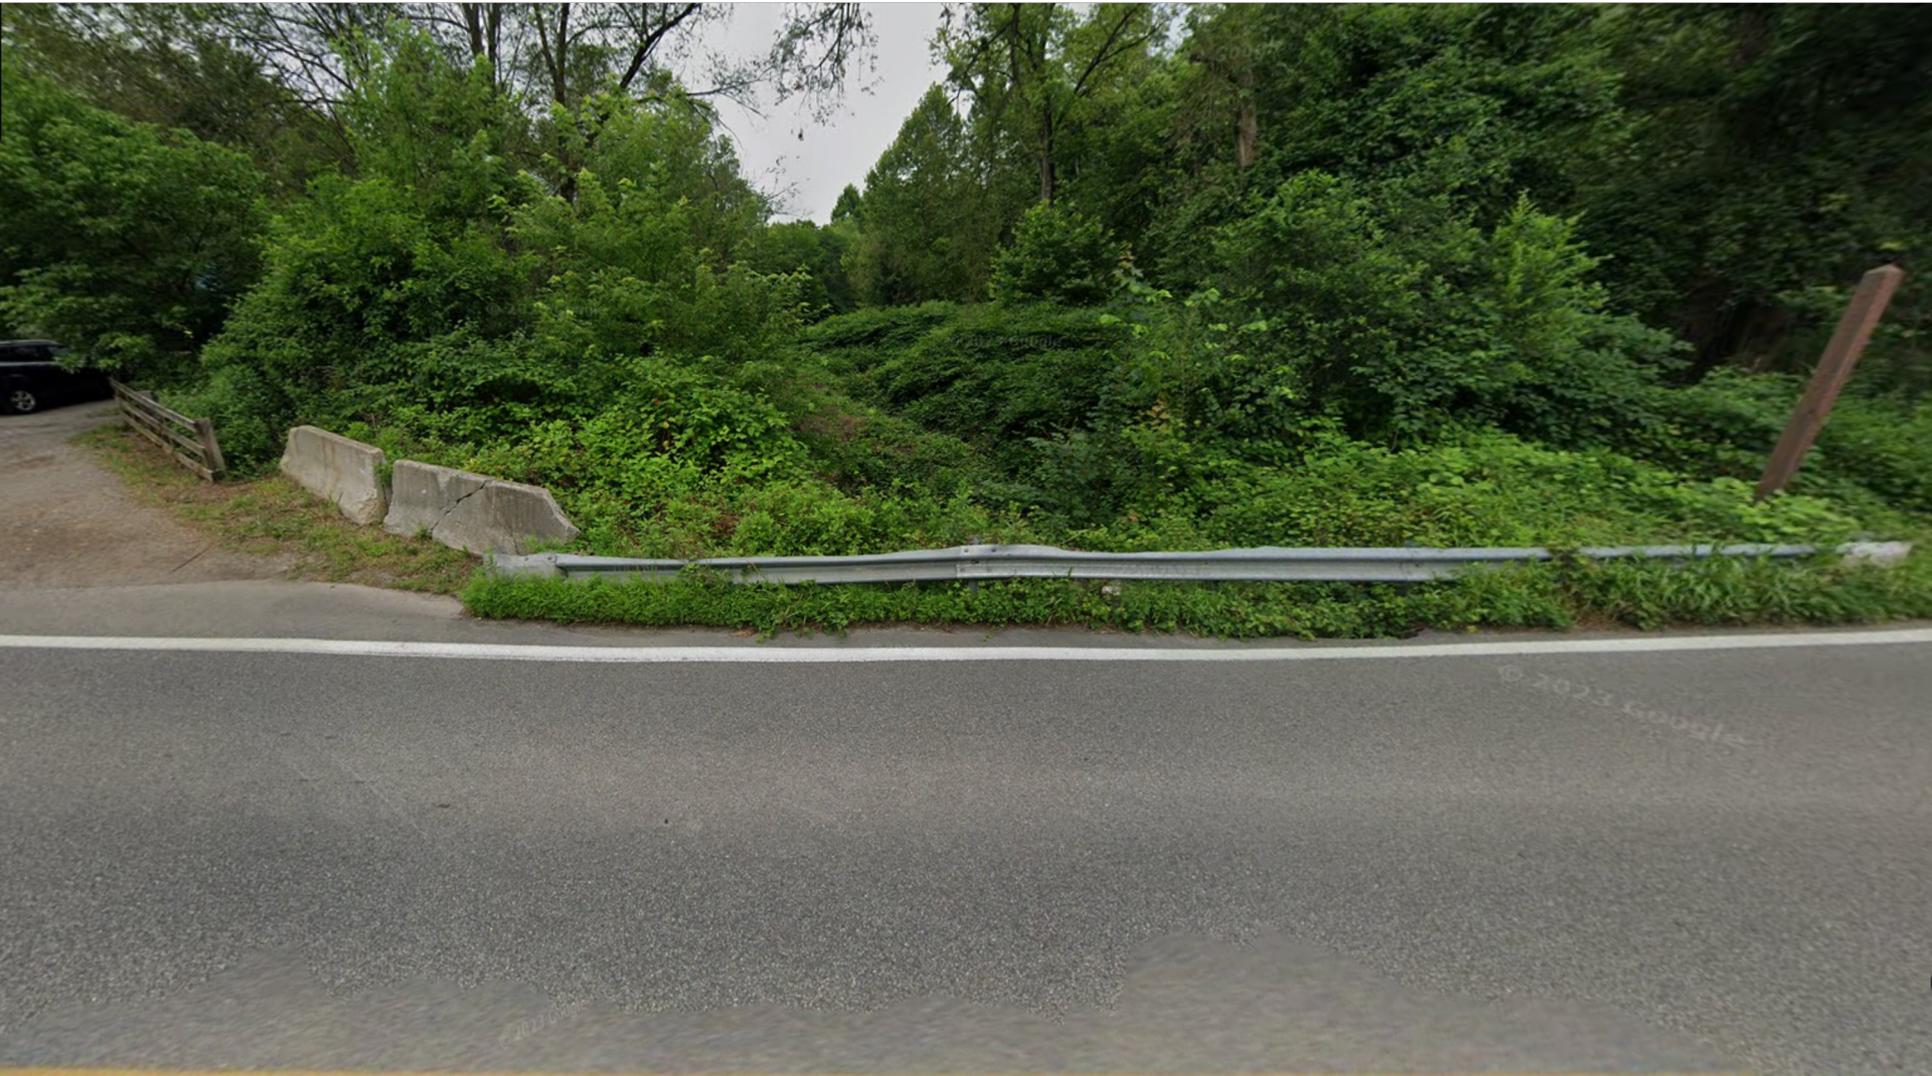
Commercial St. Culvert

View from Commercial Street looking upstream during dry weather

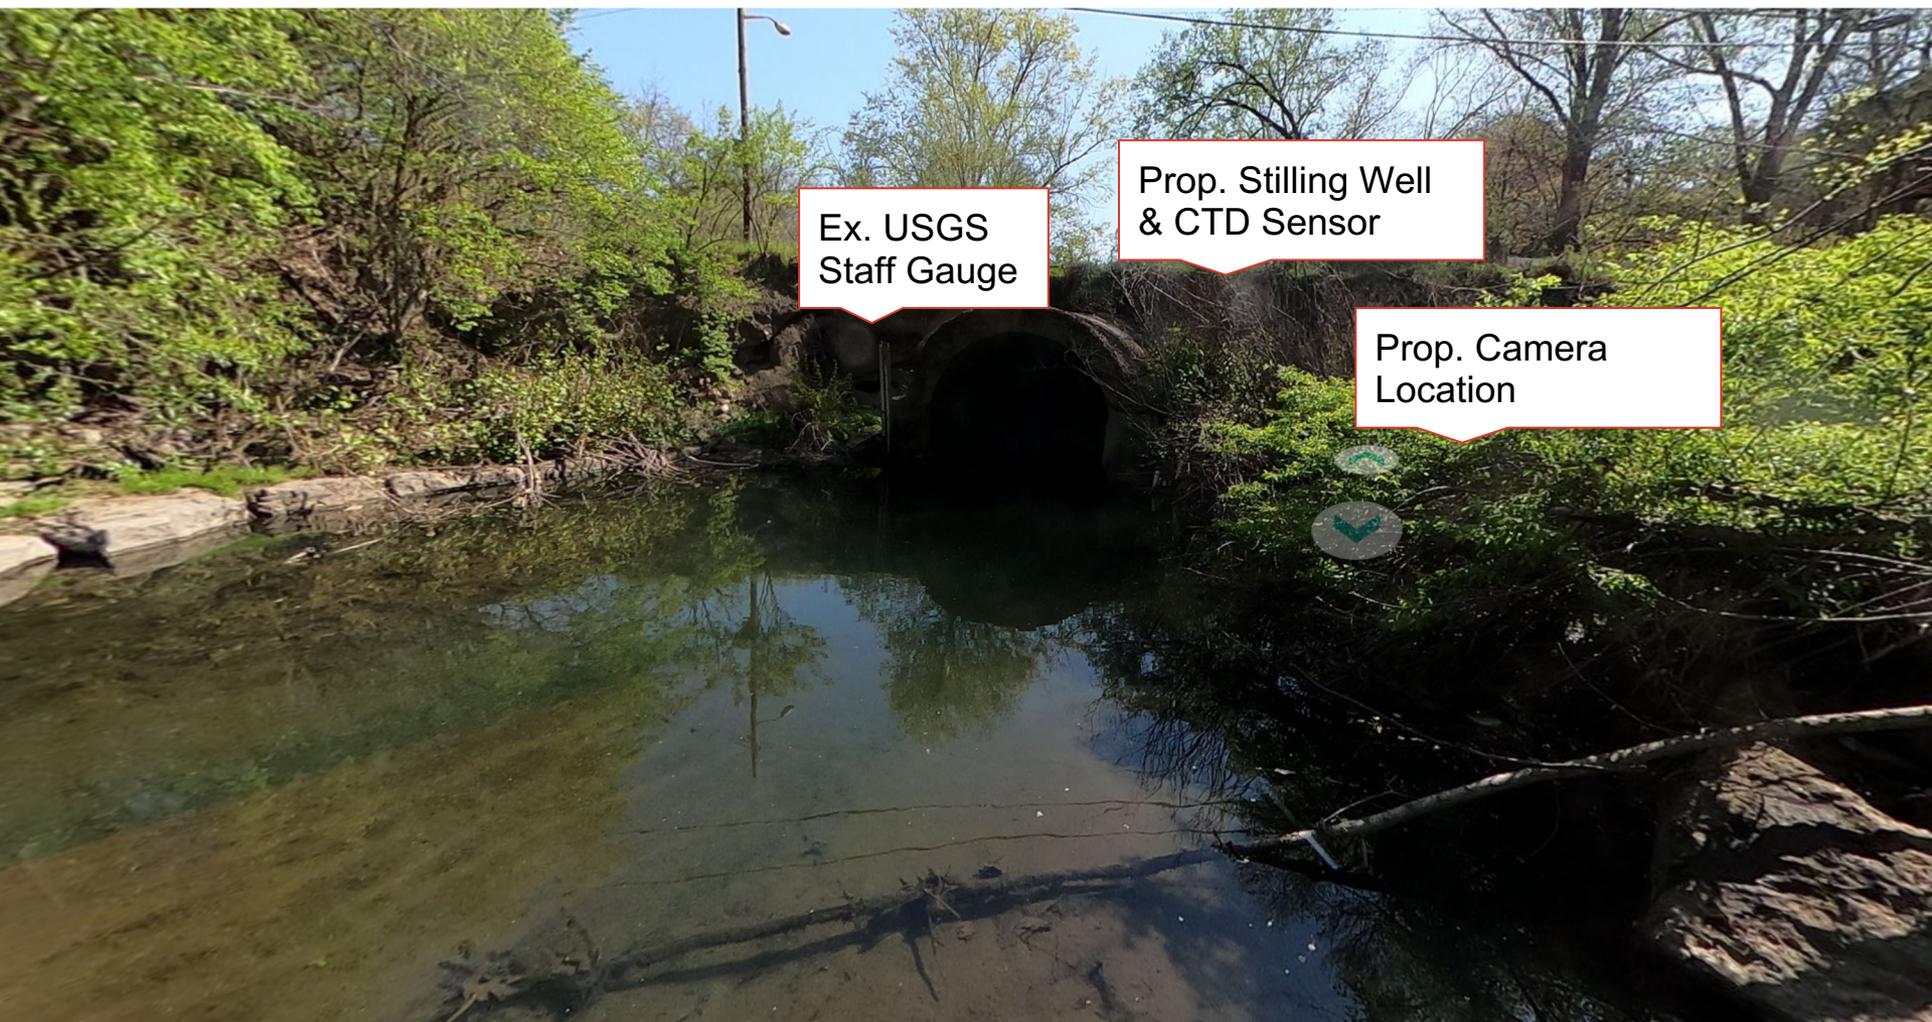
Downstream End of Commercial St Culvert

Ex. USGS
Staff Gauge

Prop. Stilling Well
& CTD Sensor

Prop. Camera
Location

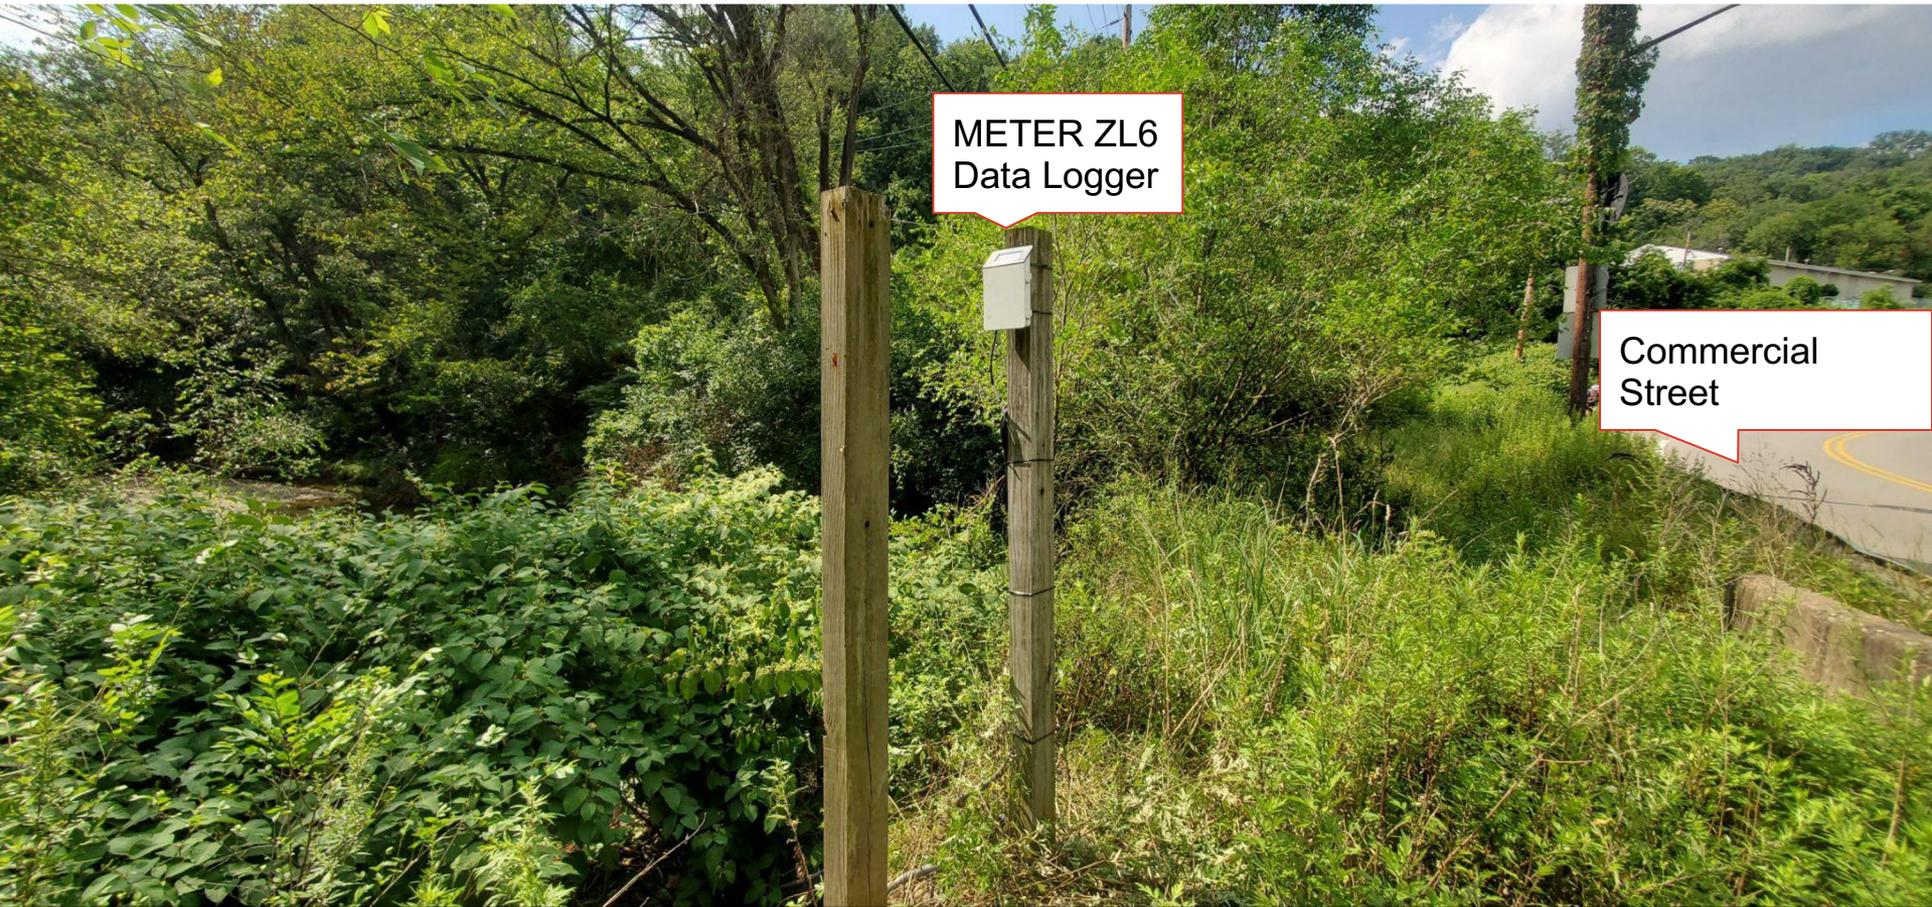
Data Logger Setup

METER ZL6
Data Logger

Commercial
Street

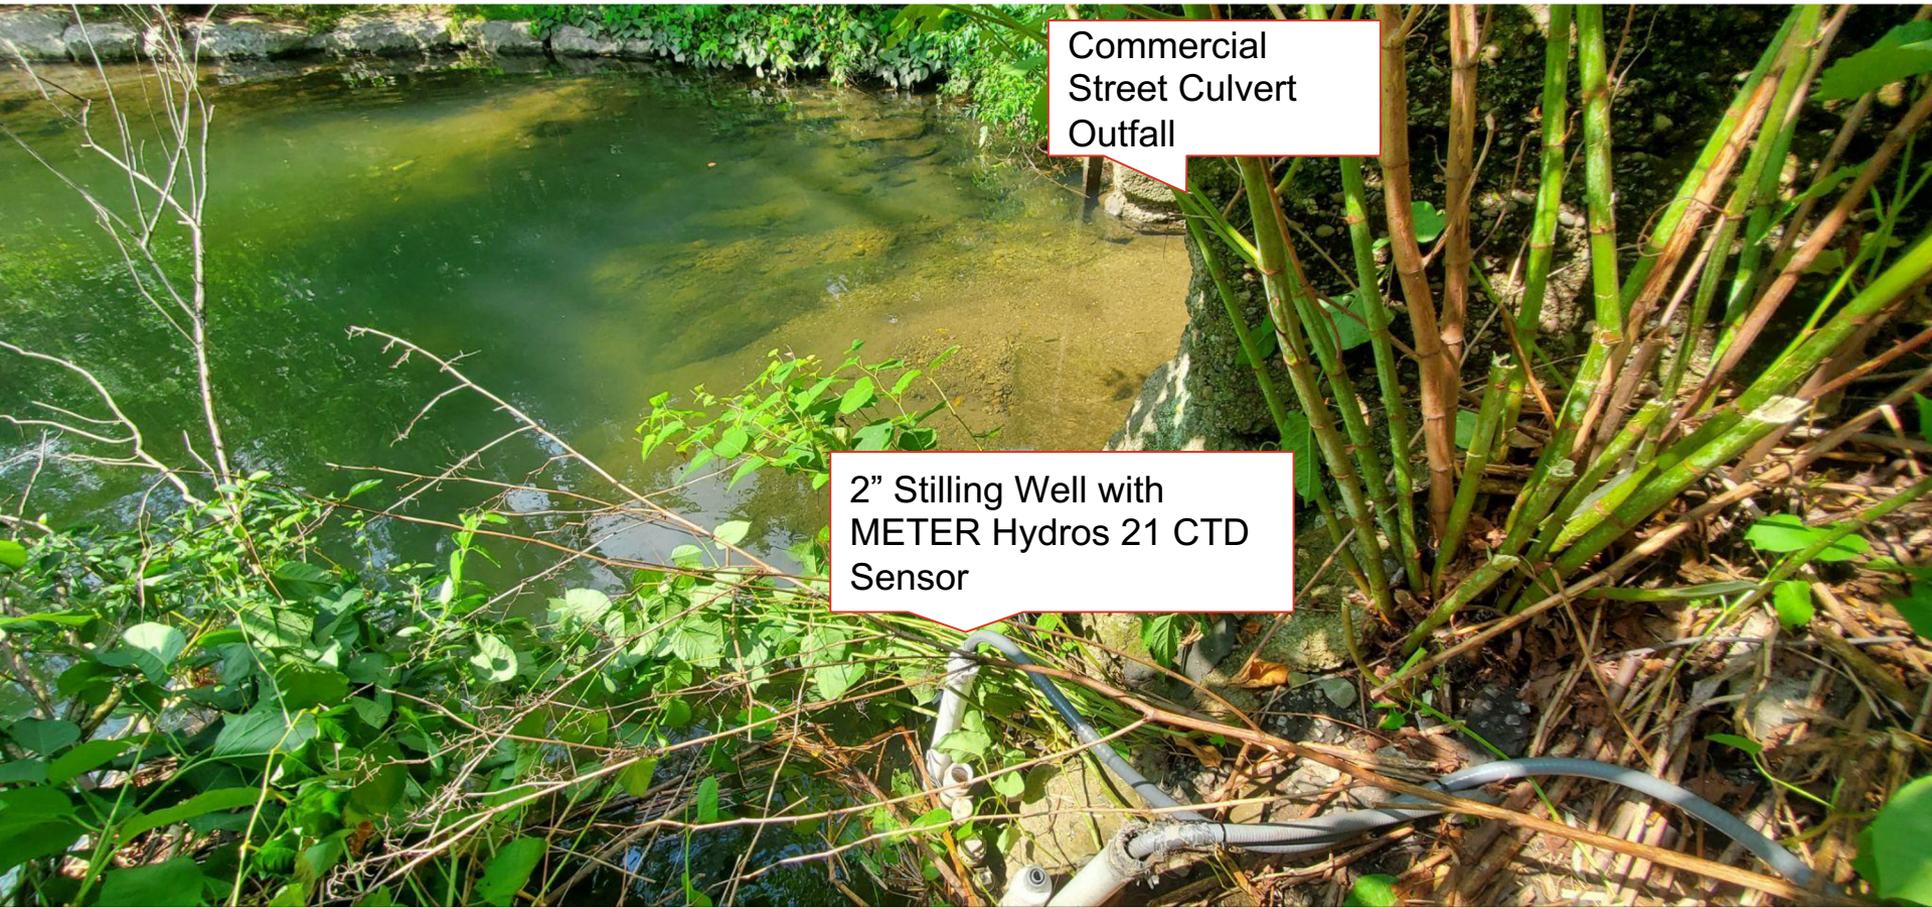
Stilling Well & CTD Sensor Setup

Stilling Well and Conductivity, Temperature, Depth (CTD) Sensor Setup

Data collection began 8/11/23

Parameters include - Water Level, Water Temperature & Electrical Conductivity (EC) logged at 5 min intervals

Commercial
Street Culvert
Outfall

2" Stilling Well with
METER Hydros 21 CTD
Sensor

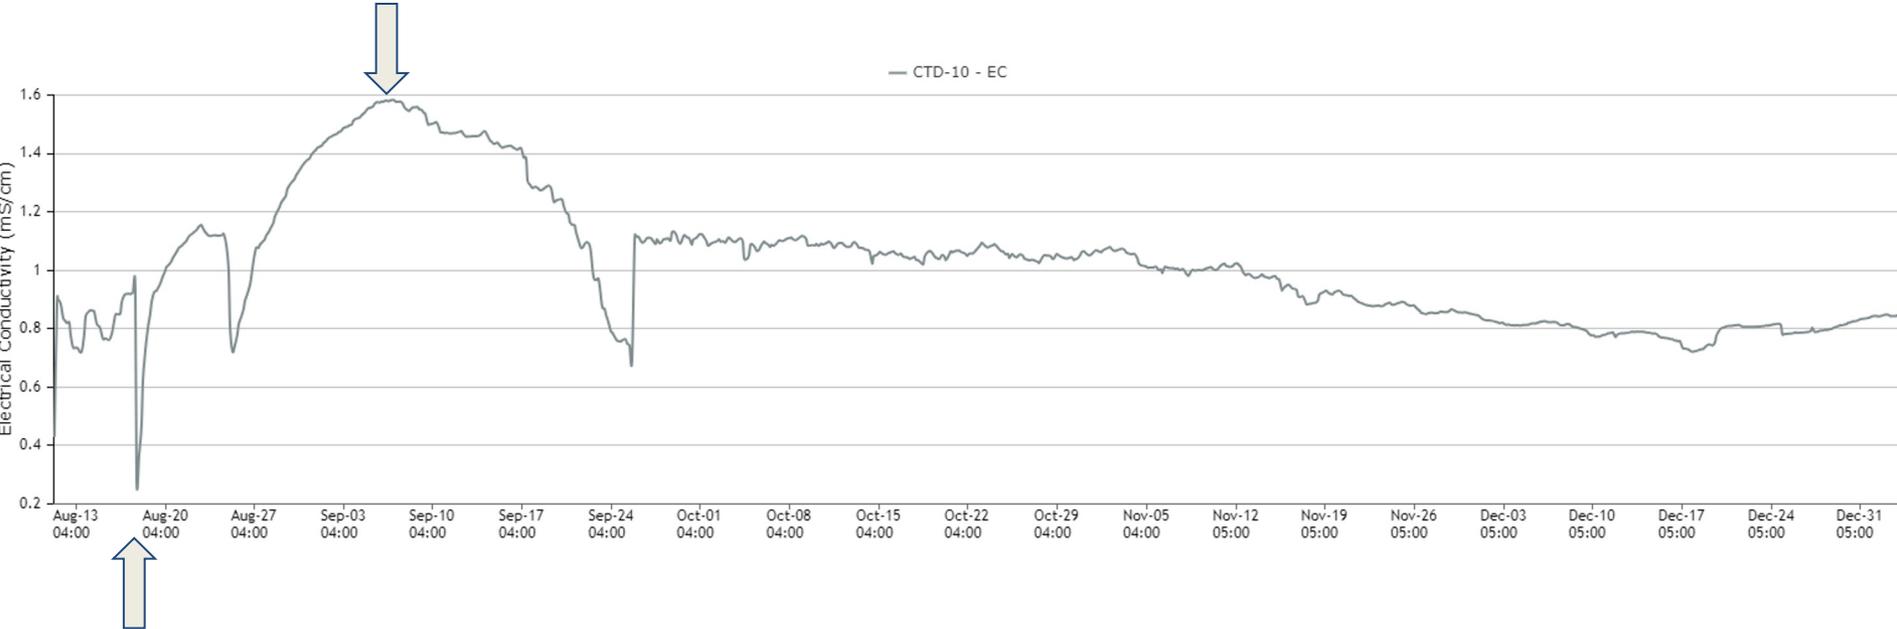
CTD Sensor Data - Electrical Conductivity

Electrical Conductivity data from 8/12/23 - 1/3/24

Max EC on 9/5/23 was 1.592 ms/cm

Min EC on 11/30/23 was 0.121 ms/cm

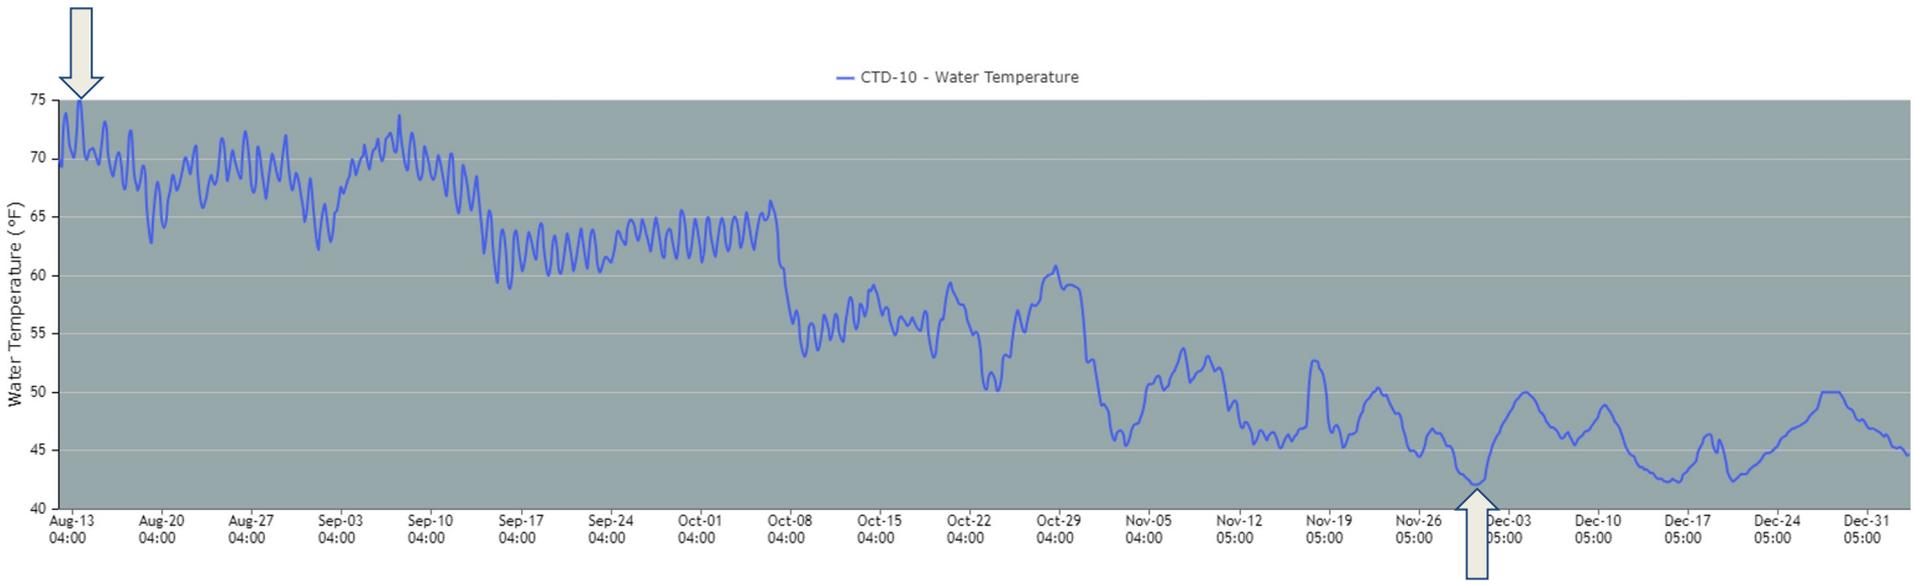
CTD Sensor Data - Temperature

Water temperature data from 8/12/23 - 1/3/24

Max Water temperature on 8/13/23 was 75.5 °F

Min Water temperature on 11/30/23 was 42.1 °F

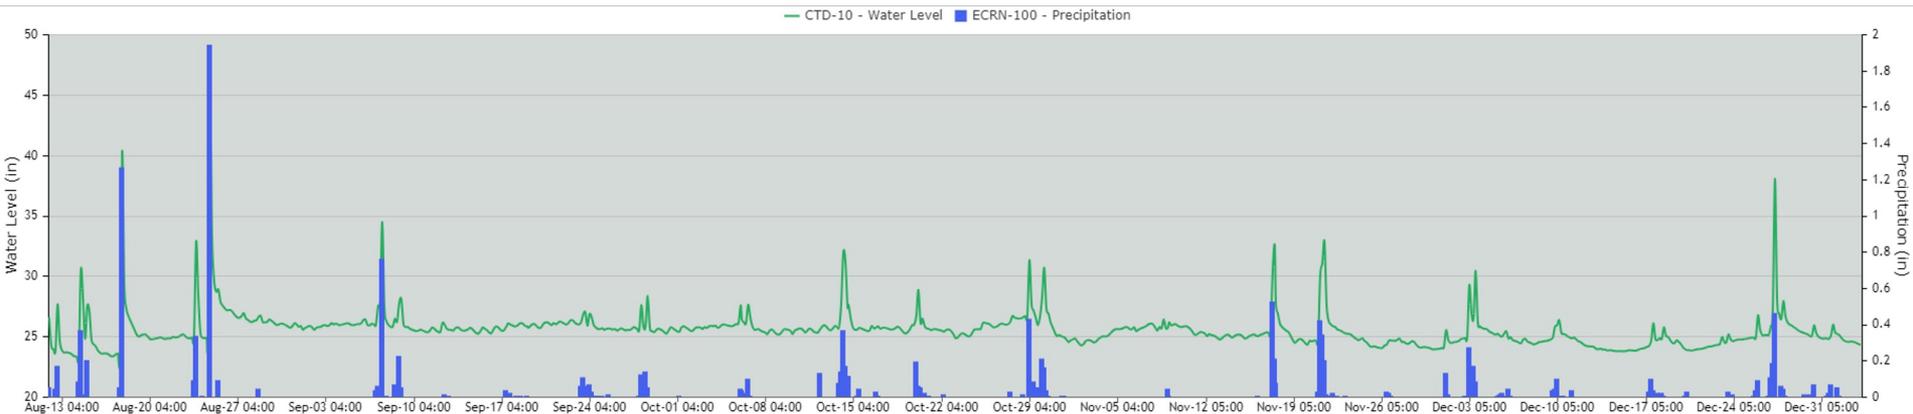
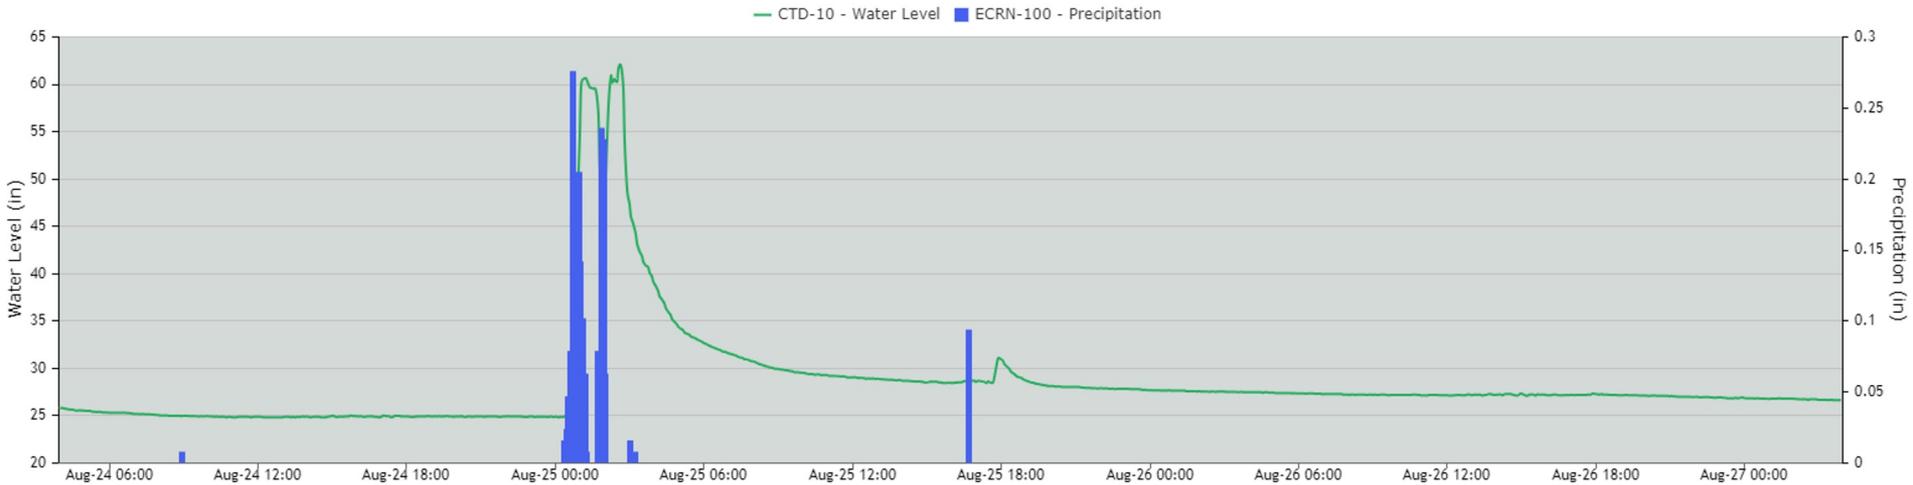
CTD Sensor Data - Water Level

Water level data from 8/12/23 - 1/3/24
Baseflow averages 25.61" or 2.13' over monitoring period

Max water level on 8/25/23 was 61.97" or 5.16' during a 2.047" precipitation event

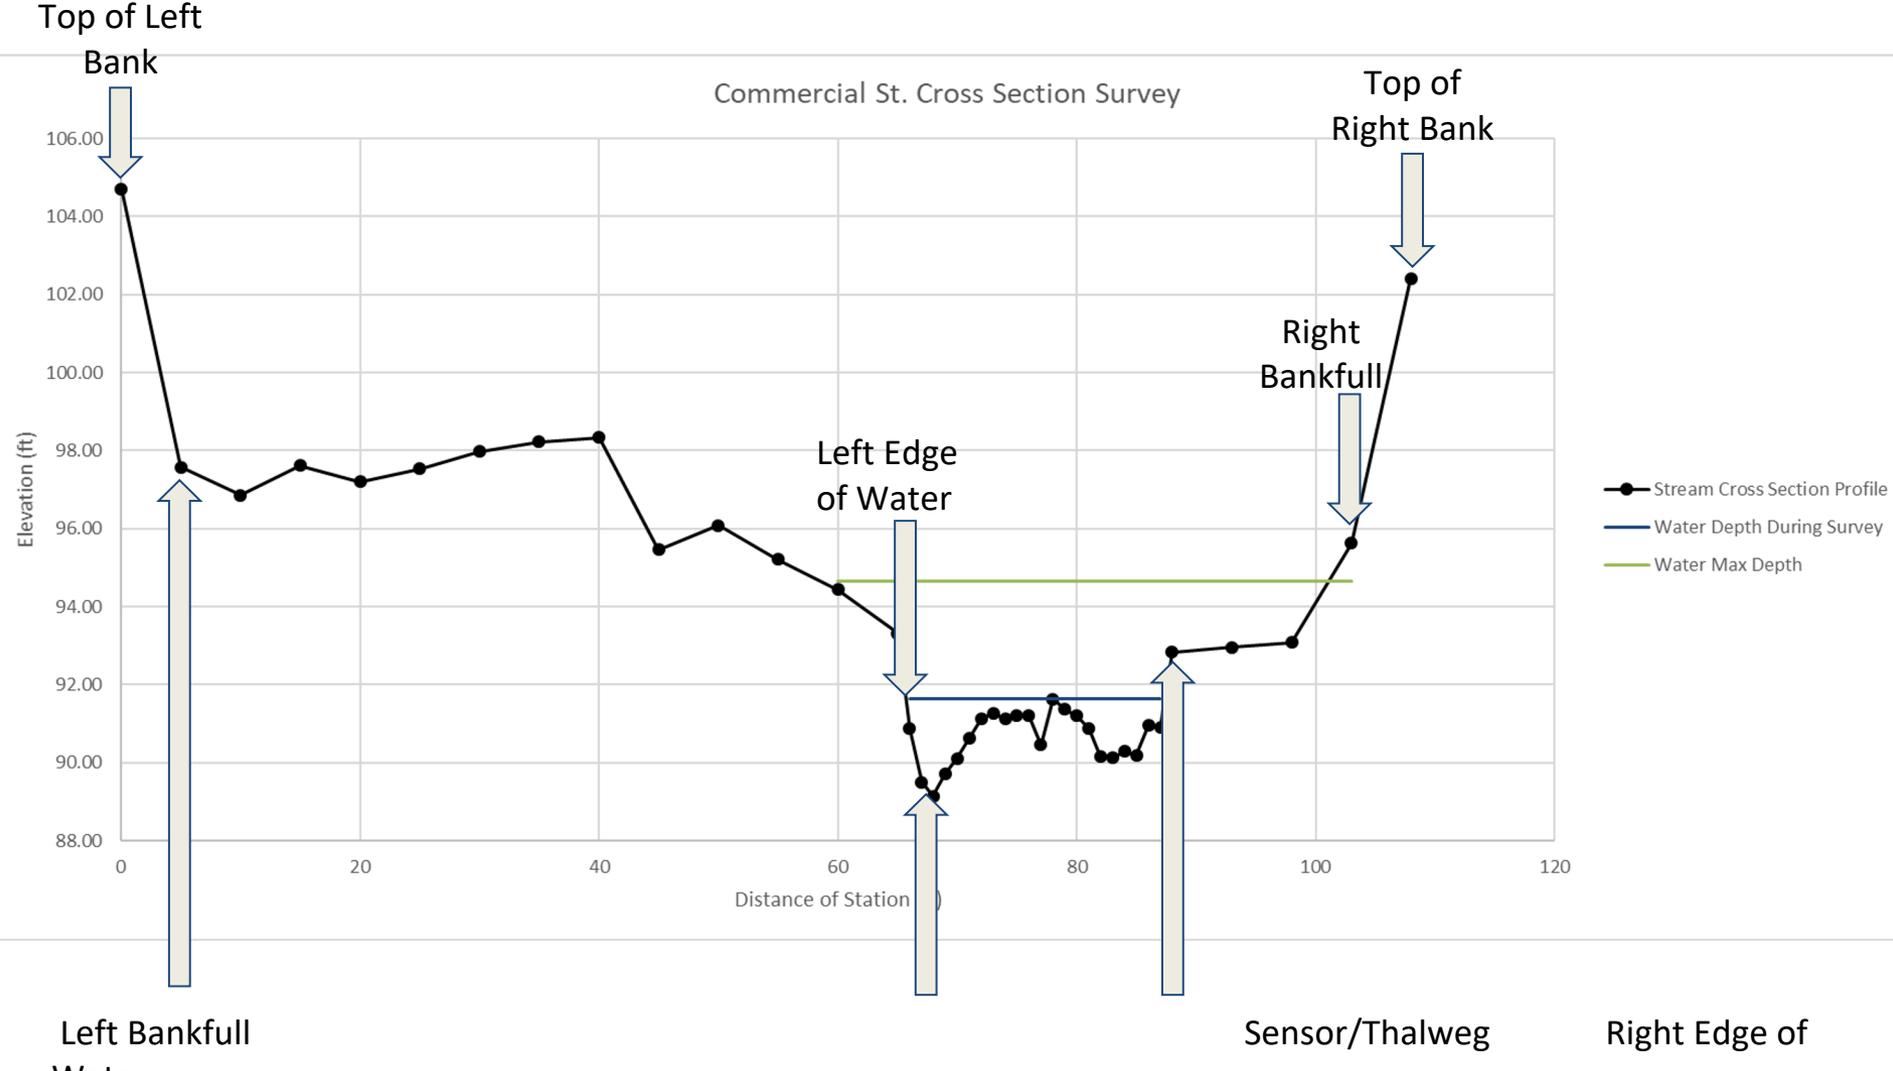
Cross-Section Survey

Completed on 10/12/23

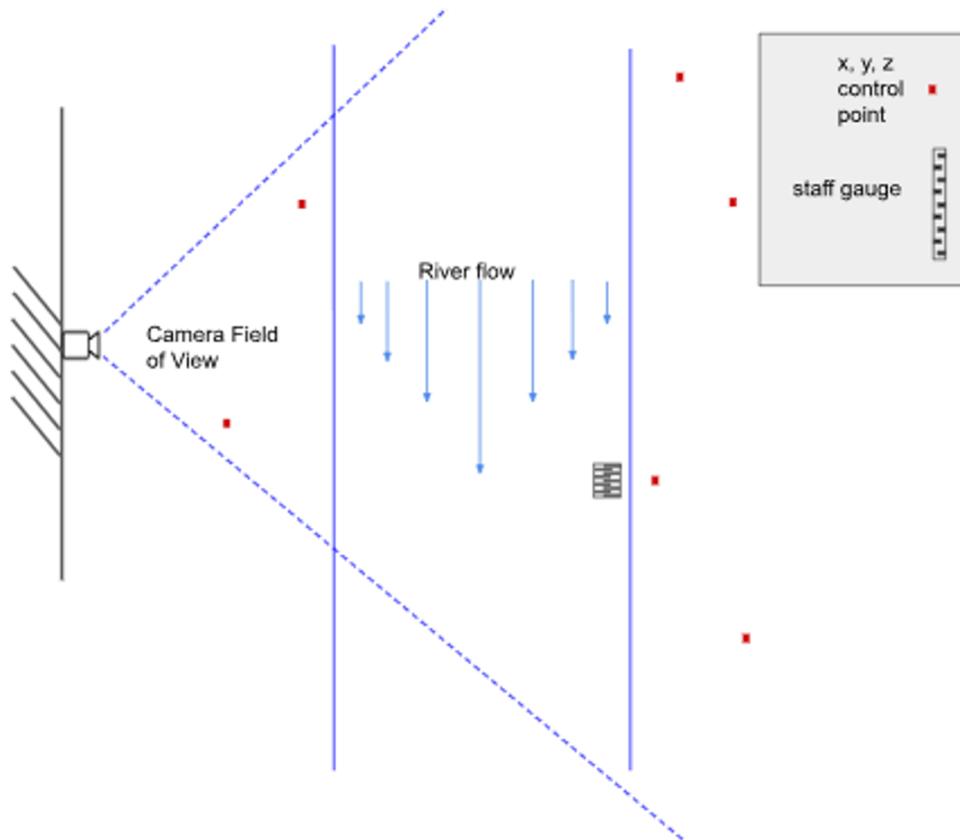
LSPIV Monitoring with pyOpenRiverCam

Planar schematic view of site survey situation.

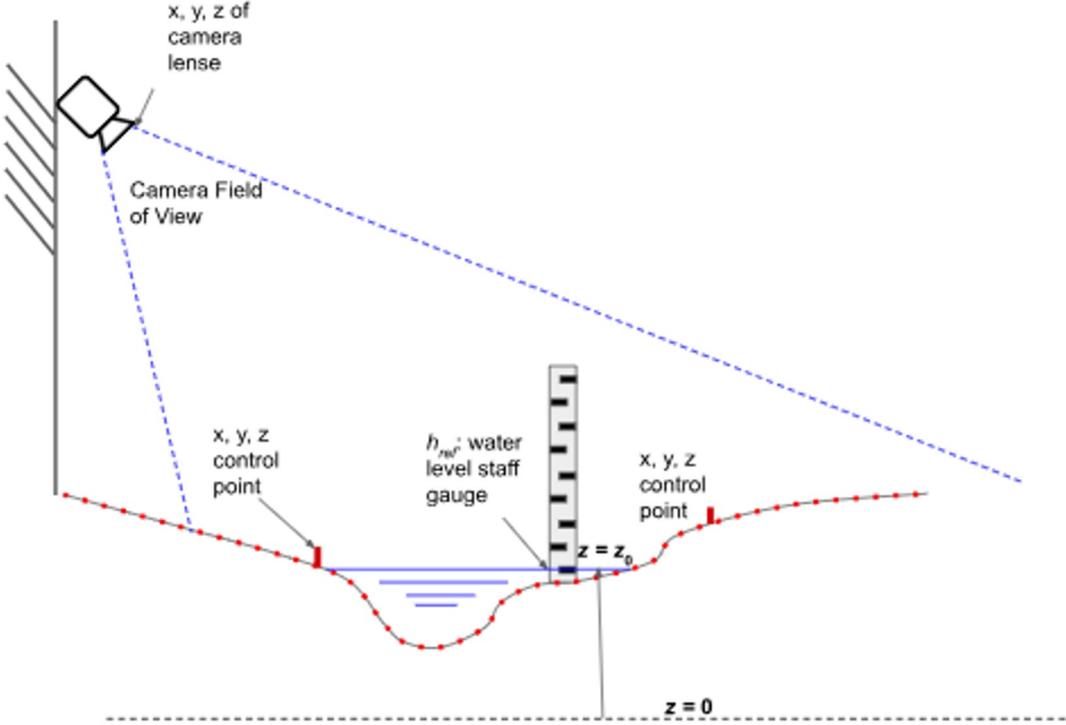
LSPIV Monitoring with pyOpenRiverCam

Cross-section schematic view of site survey situation. #
