Houston Ball Field Erosion Study

A 3RQ GAPS Project with the Upper Chartiers Creek Watershed Association

Sarah Nelson
Civil Engineering Major and WVWRI Student Worker

1/16/2025
WVWRI Seminar Series

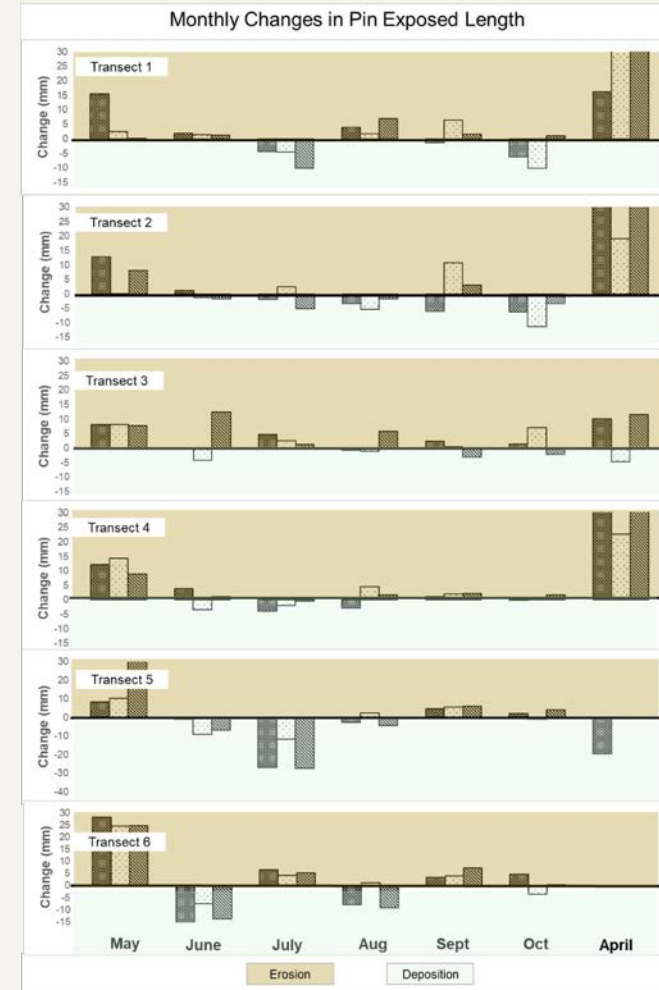
Average net erosion (first 6 months): 7.35 mm

Average net erosion (entire year): 33.96 mm

One pin showed as much as 101.29 mm (4 inches) of erosion!

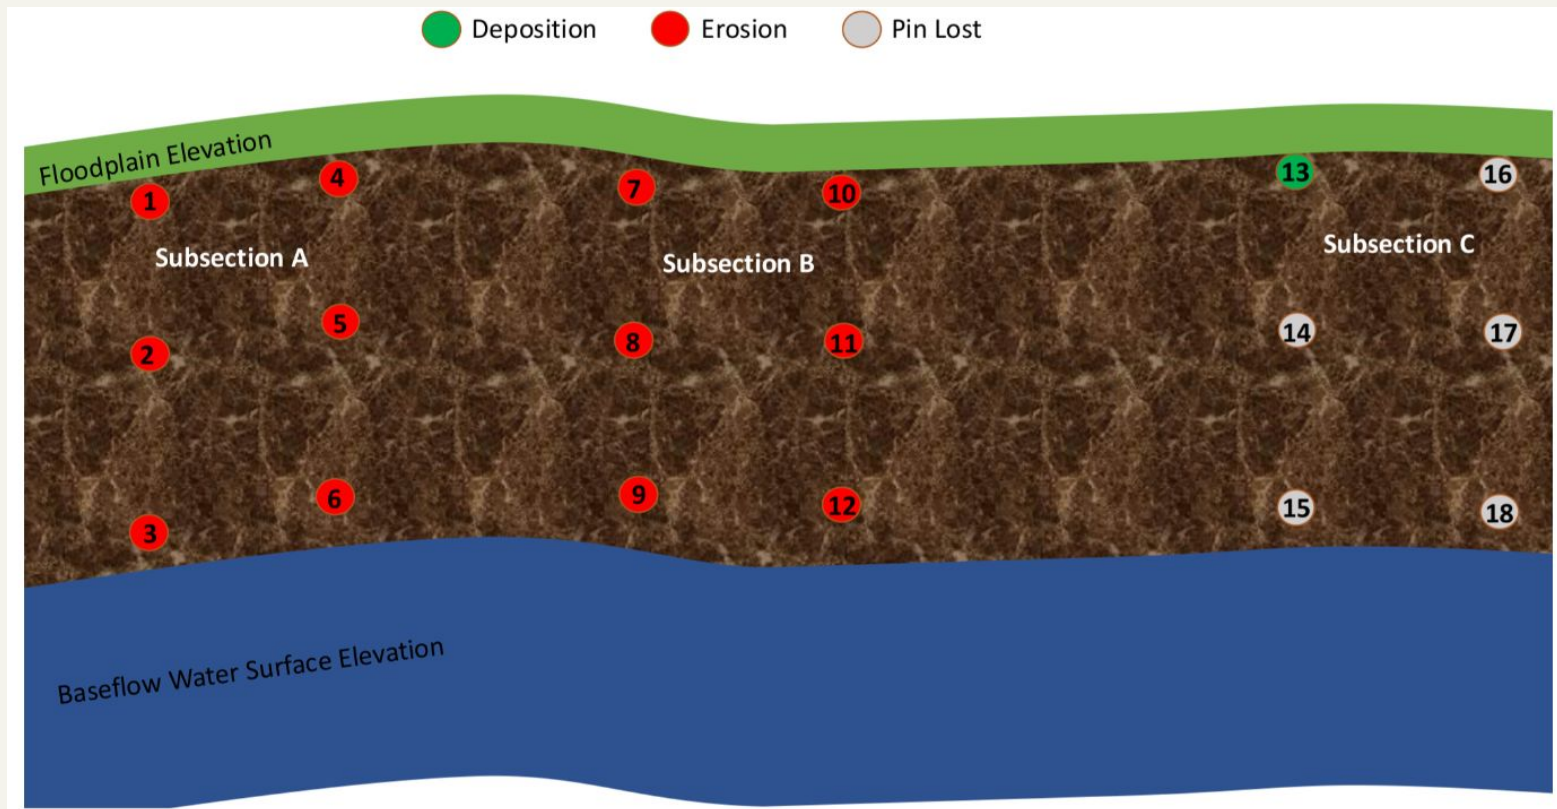
- Erosion was measured (visually and numerically) at all three subsections
- 5 of 6 pins located in subsection C were washed out in winter/early spring, indicating that it should be prioritized for streambank stabilization
